SandTrap[®]

**Covema y Obras**

Screen system to intercept the winds and capture their sand content.

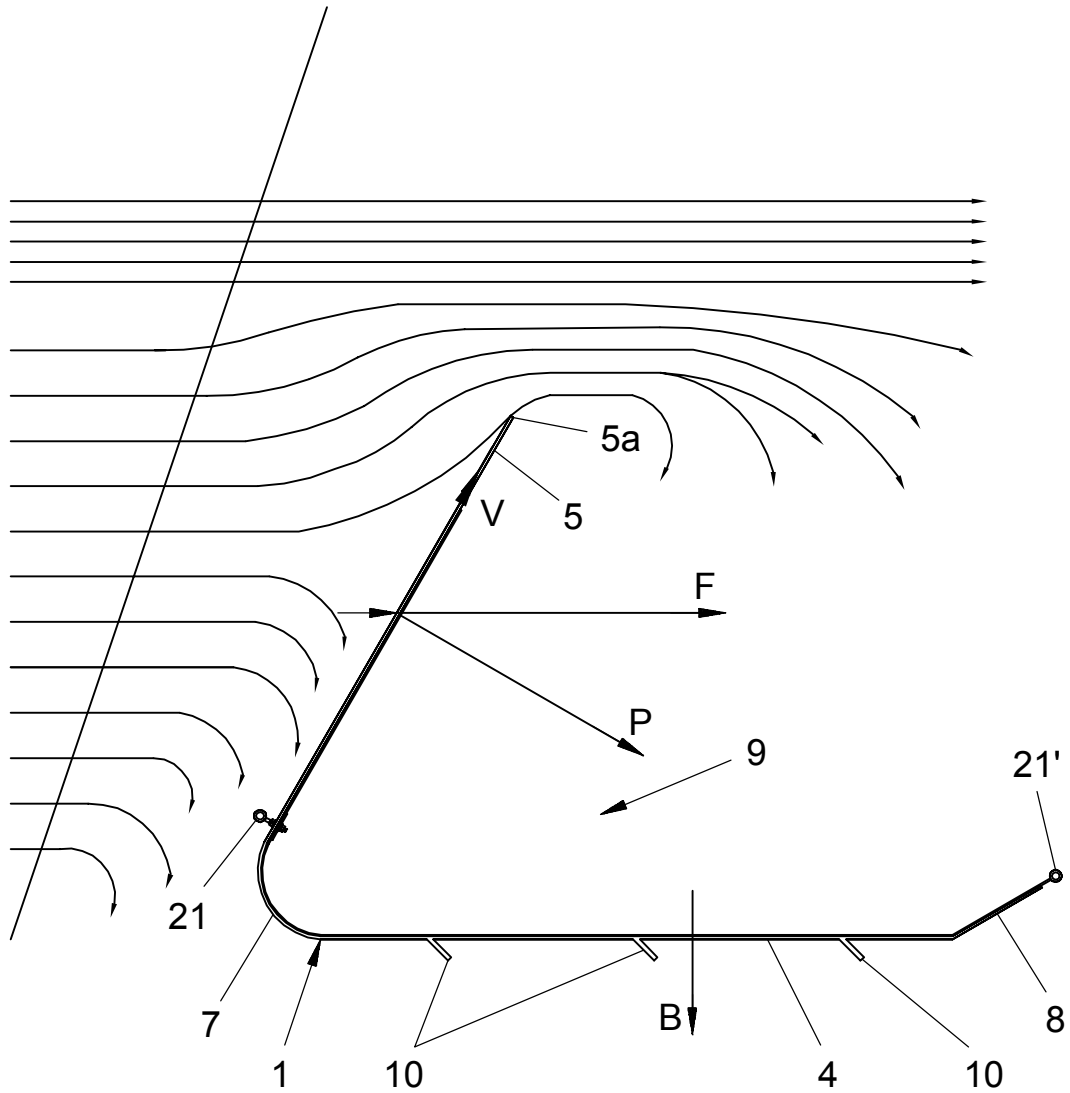
FIG. 1

WIND BEHAVIOR IN YOUR MEETING WITH THE SCREEN

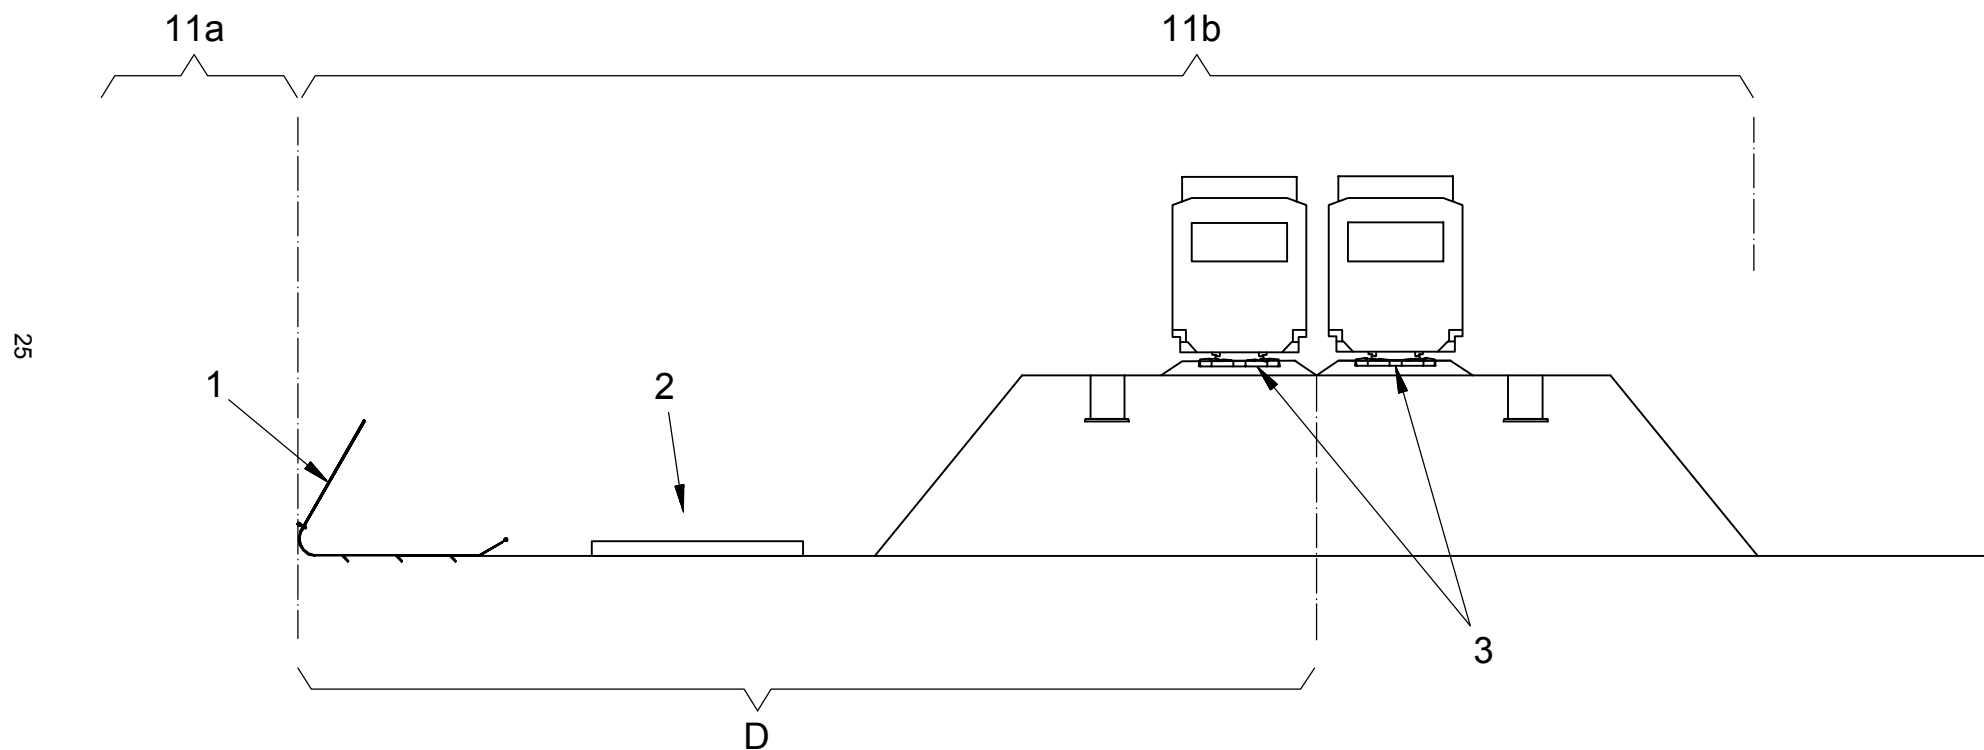
FIG. 2

SITUATION OF THE SCREEN WITH REGARD TO THE RAILWAY (DE = 40M)

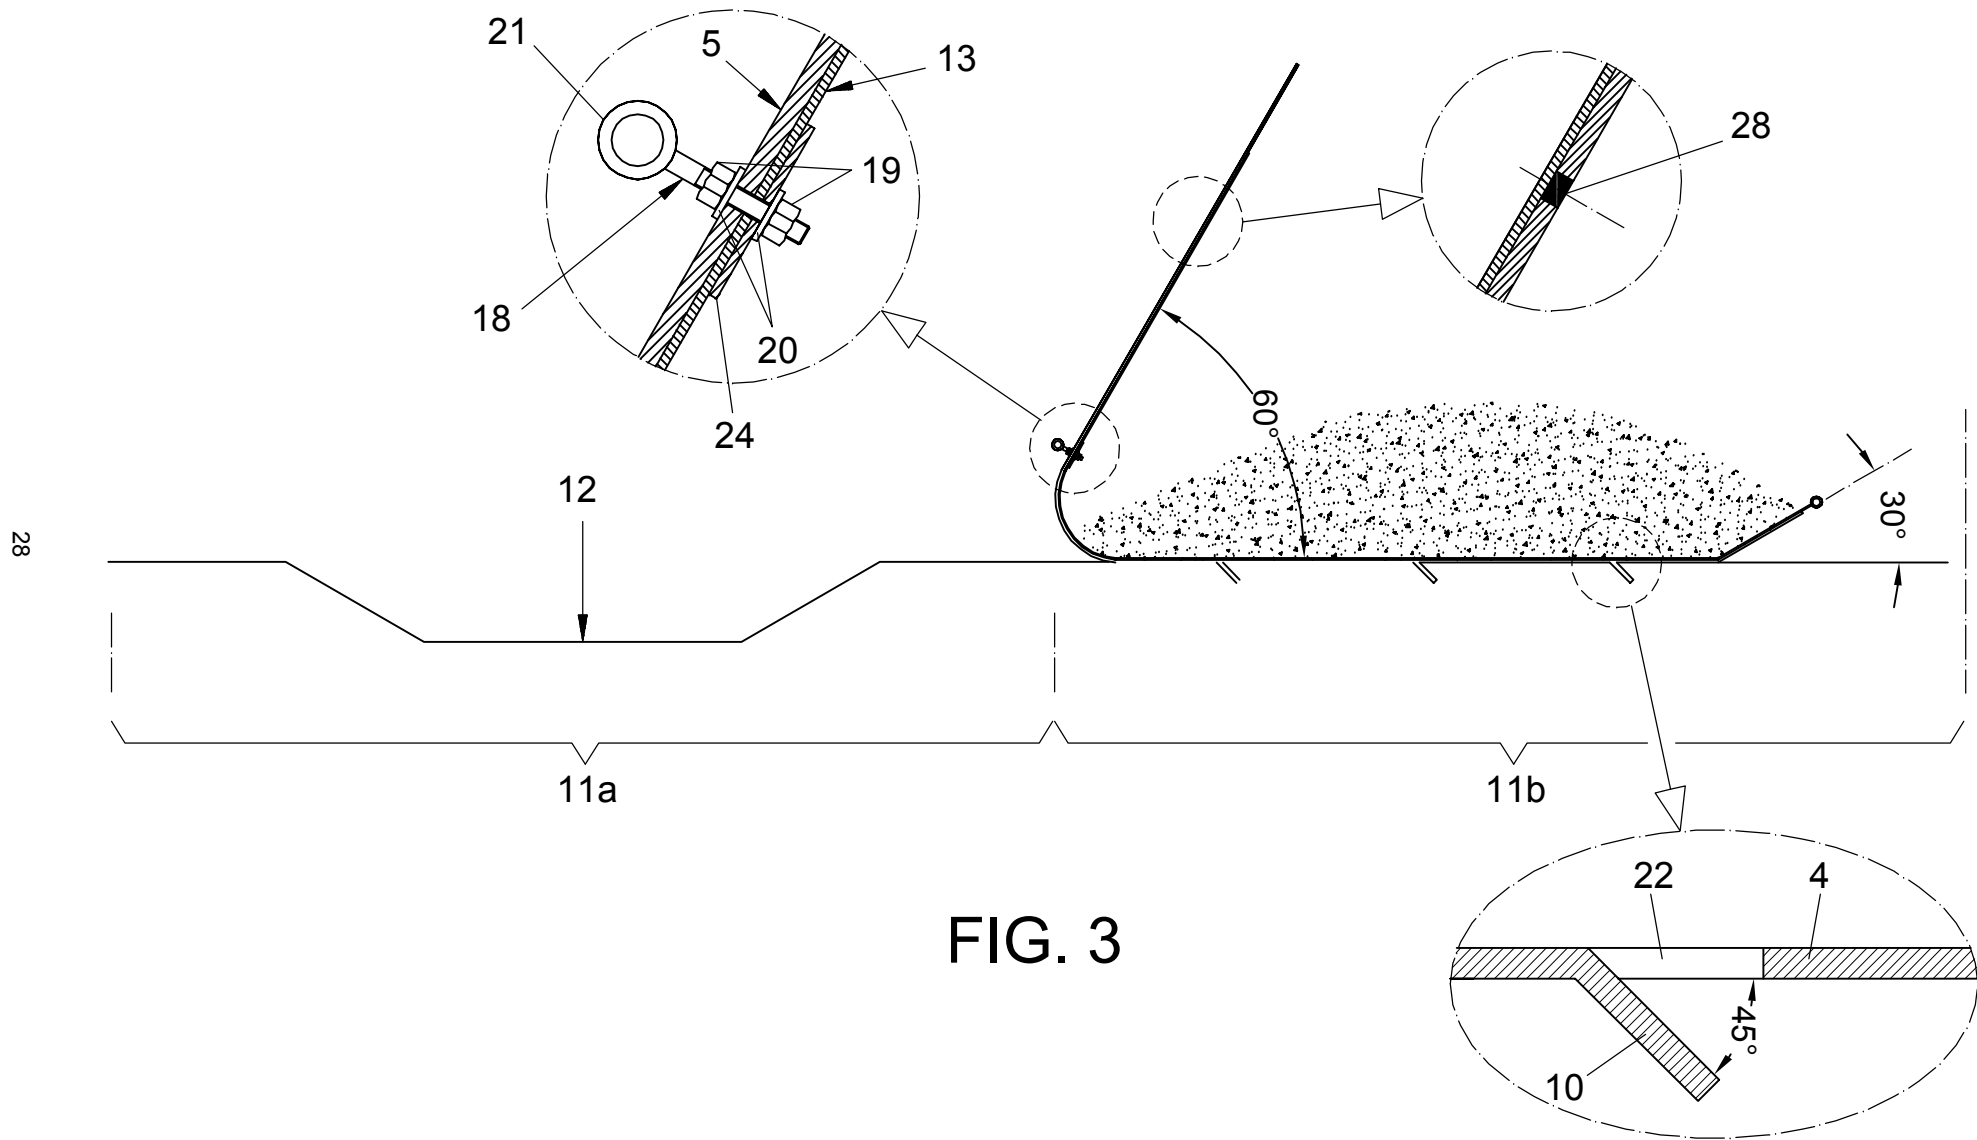
FIG. 3

EMBEDDED TABLECLOTH ON THE FLOOR

Some holes are drilled in the horizontal base to enable the discharge of the soil mass in the event of disassembly. As a consequence of the creation of these gaps, a flap is formed in each of them which, if oriented and secured in the ground, will serve as a brake on the possible displacement of the system by the wind thrusts (FIG 3).

In order to increase the capacity of the sand protection system, some pits are dug in front of the screens (FIG 3). The result of the excavation is used to load the screens of soil on its horizontal plane. The trench thus formed serves to capture part of the wind-borne sands.

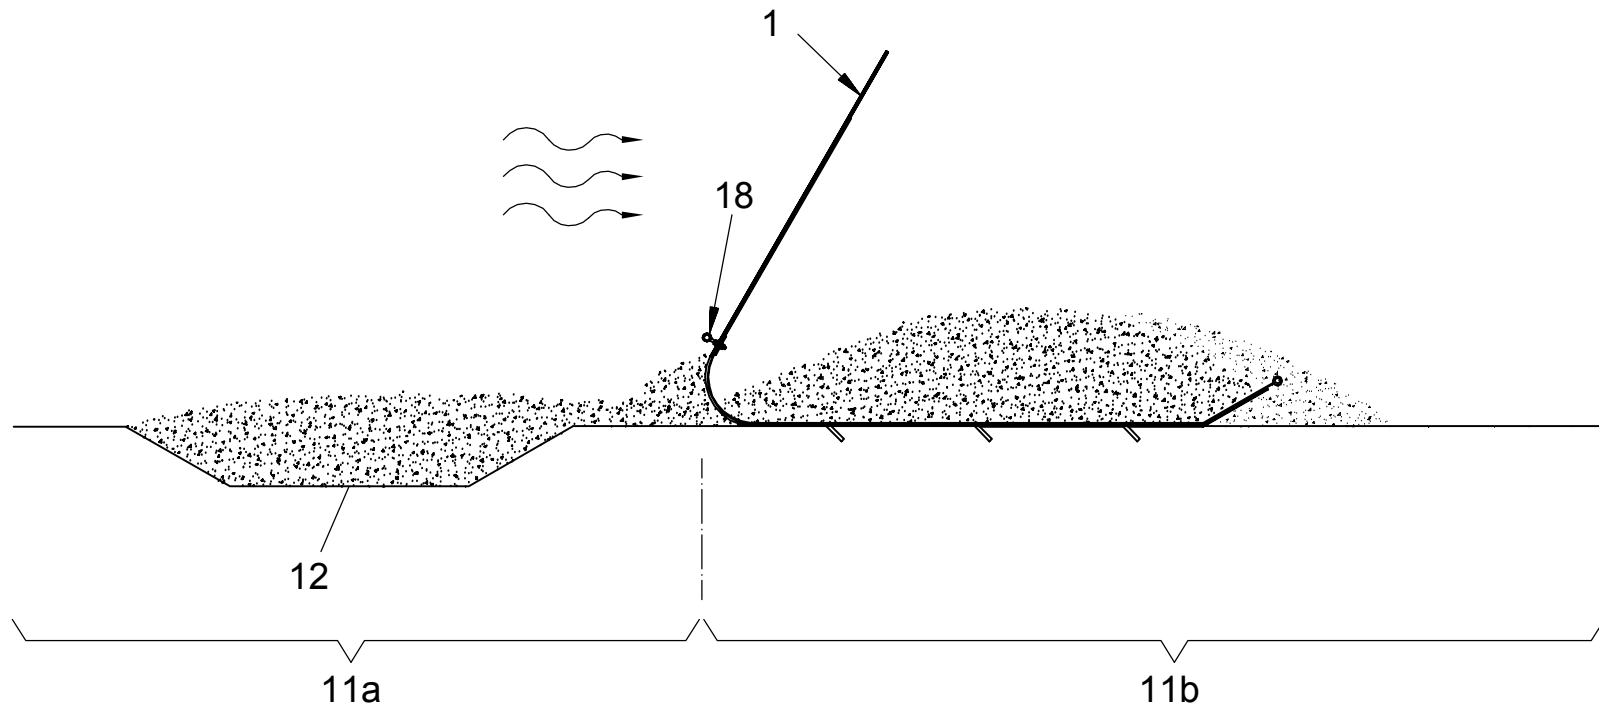
FIG. 4

LOADED SAND SYSTEM

When the accumulation of sands in the system environment is large enough, the system loses its effectiveness and is disassembled (FIG. 4) as follows:

- The structure is slowly raised using the rings and letting out as much soil contained in its horizontal base as possible. The action of emptying the structure of soil is completed by overturning the whole construction.
- The sand accumulated is spread in the same place, creating a new level regarding the initial level and the screen is located in the same place (FIG 5).

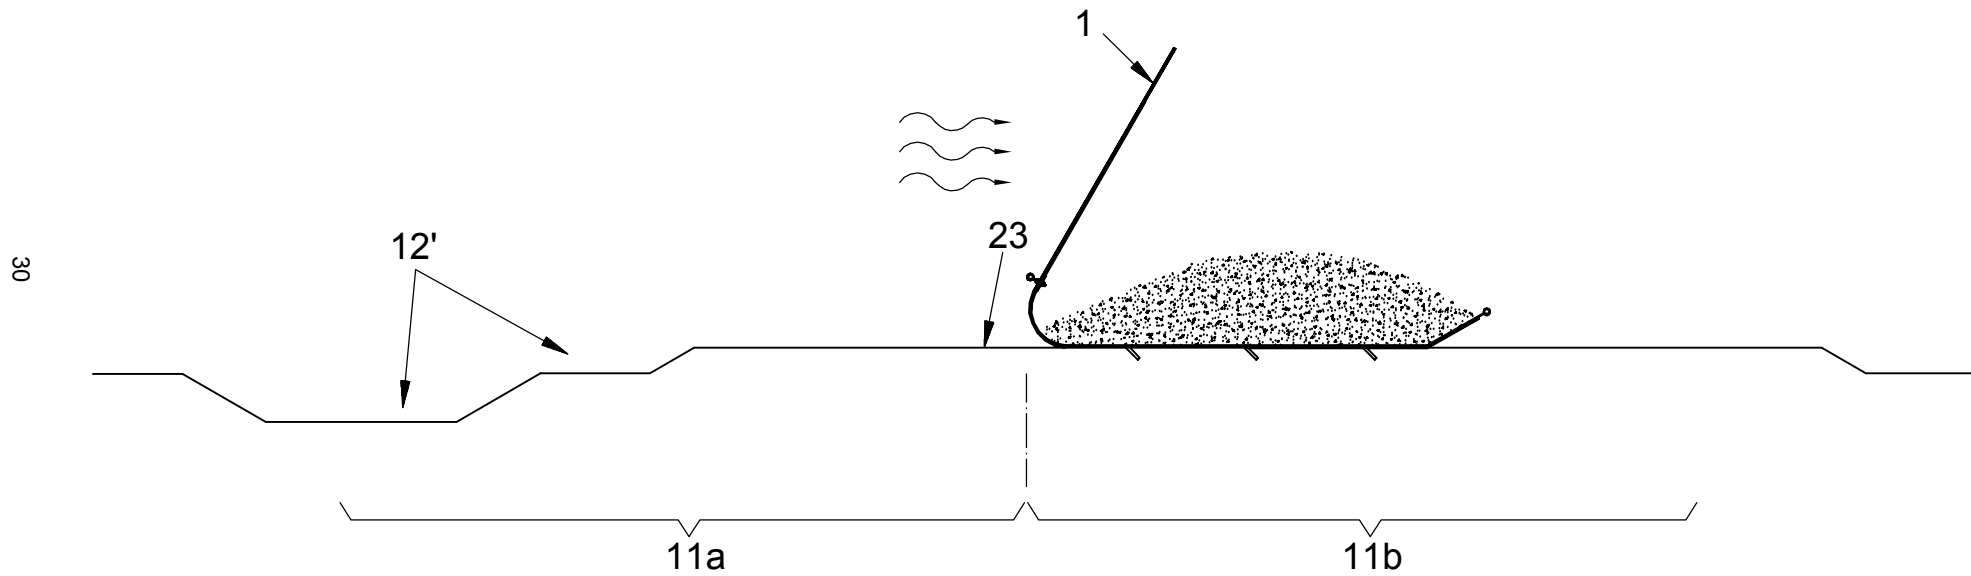
FIG. 5

DISASSEMBLY AND NEW SYSTEM PLACEMENT

The assembly formed in this way has greater height compared to the initial level.

The trench is dug again in front of the screen and the horizontal base is loaded with the excavation remains so that the system becomes operational again.

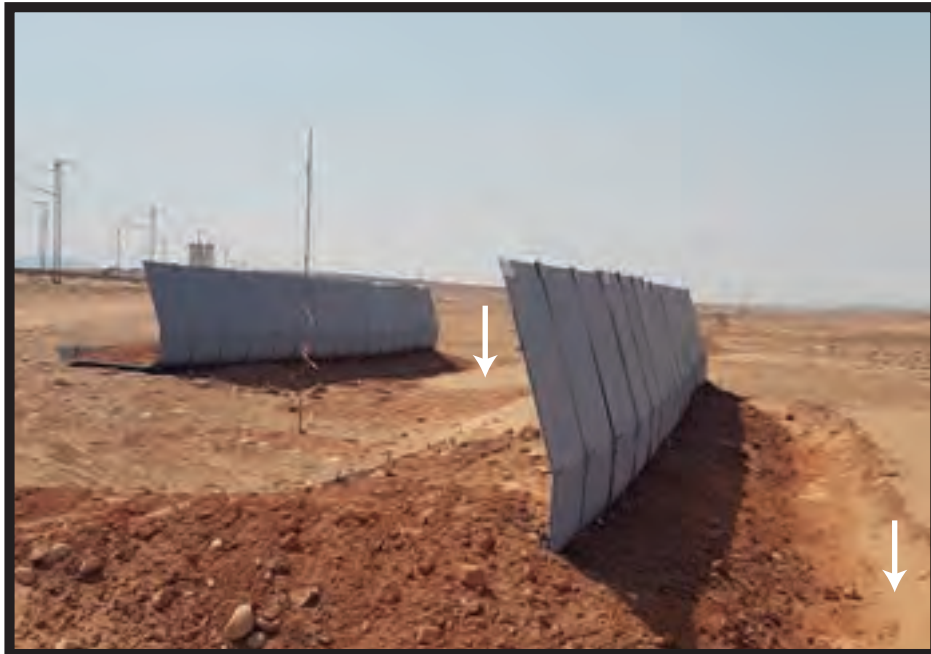
STATUS OF THE SYSTEM MISSING ONE MONTH OF ITS PLACEMENT.
IT CAN BE STARTED TO APPRECIATE SAND ACCUMULATION

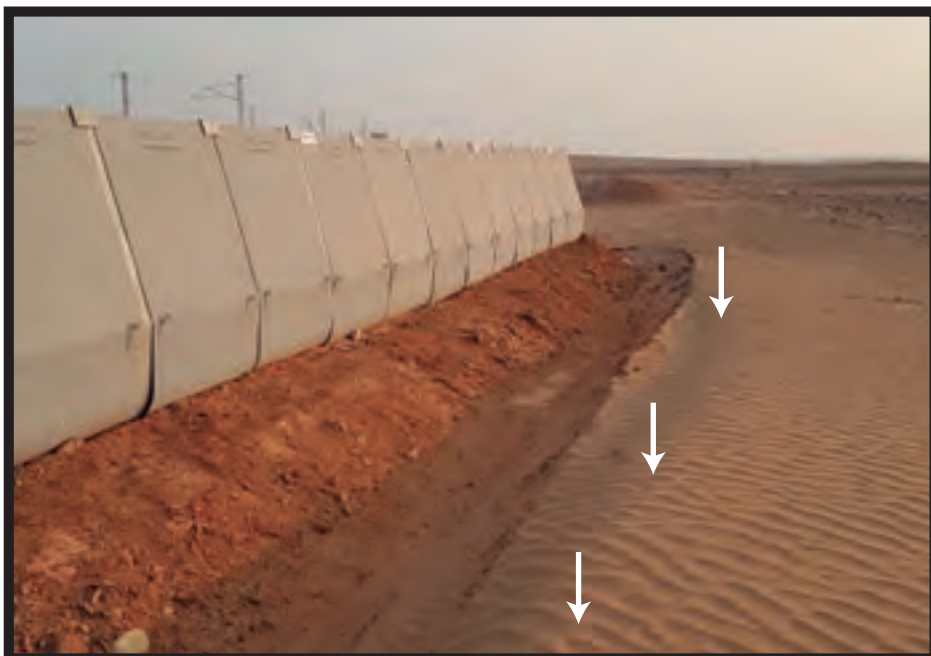
STATE OF THE SYSTEM MISSING THREE MONTHS OF ITS PLACEMENT.
ACCUMULATION OF SAND START TO HIGHLIGHT

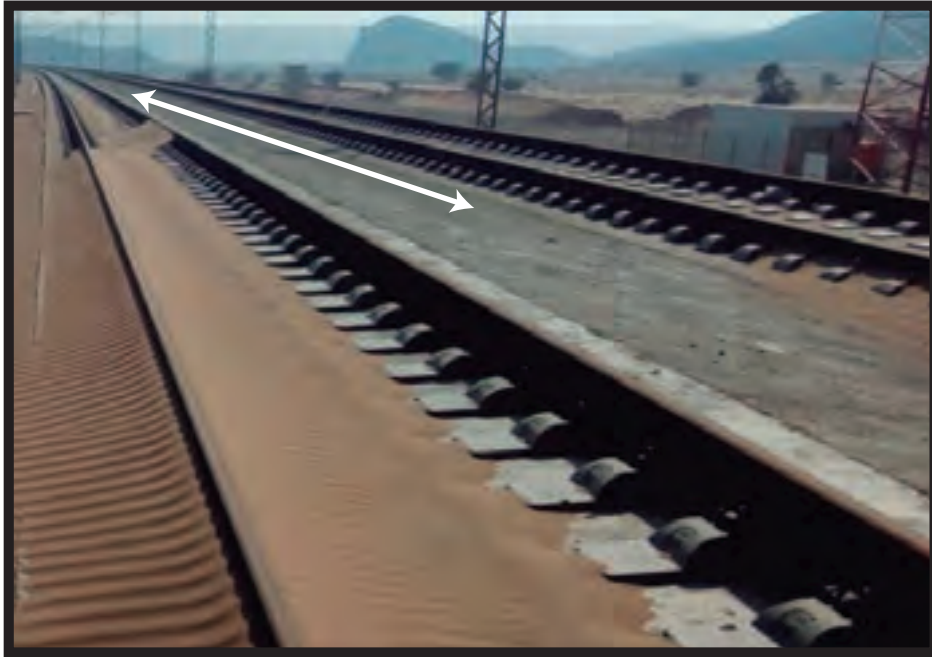
WE CAN OBSERVE THE SAND LACK ON THE RAILWAYS.
DUE TO AN AUXILIARY WORK THAT WAS PERFORMED TO PROTECT AN INSTALLATION

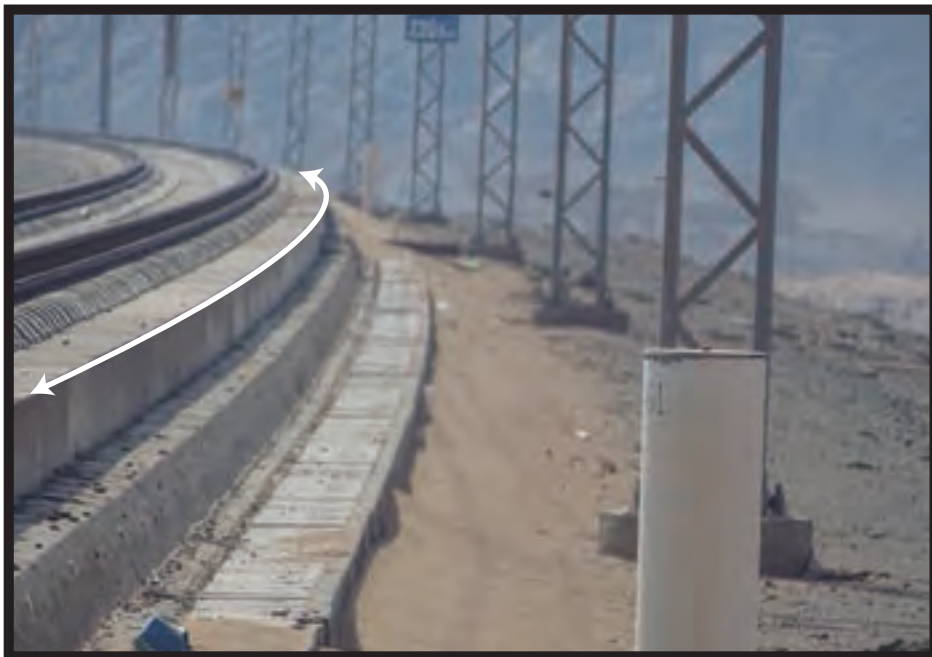
VIEWING MORE DETAILS OF THE ARENA DEMAND ON THE RAILWAYS

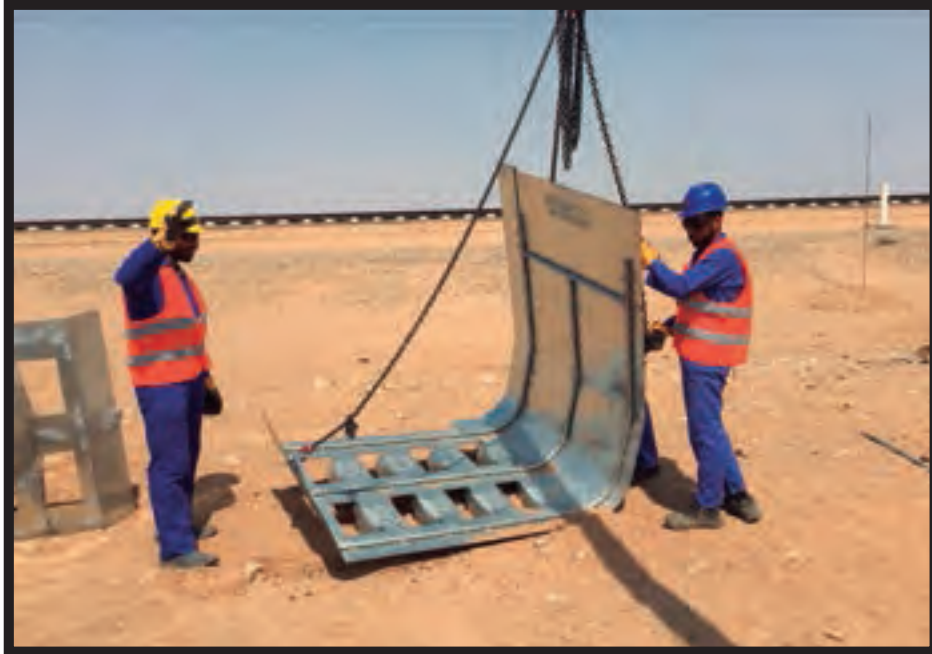
ELEMENT WHERE THE GROUNDING TABLES ARE APPRECIATED

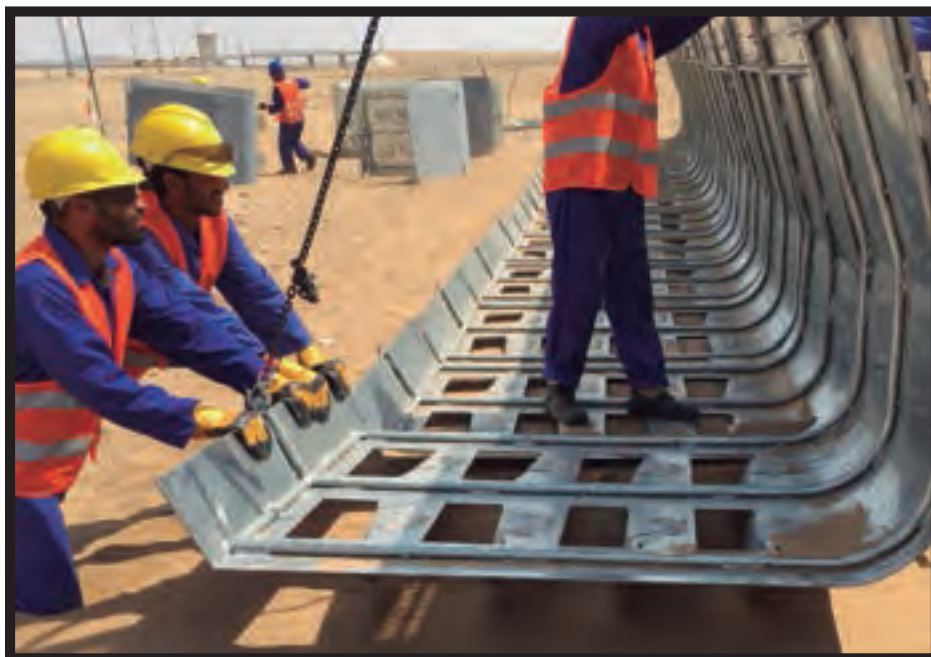
ASSEMBLY OF THE STRUCTURE
